## 2 Existing Environment and Harbour

## **2.19 Harbour condition**

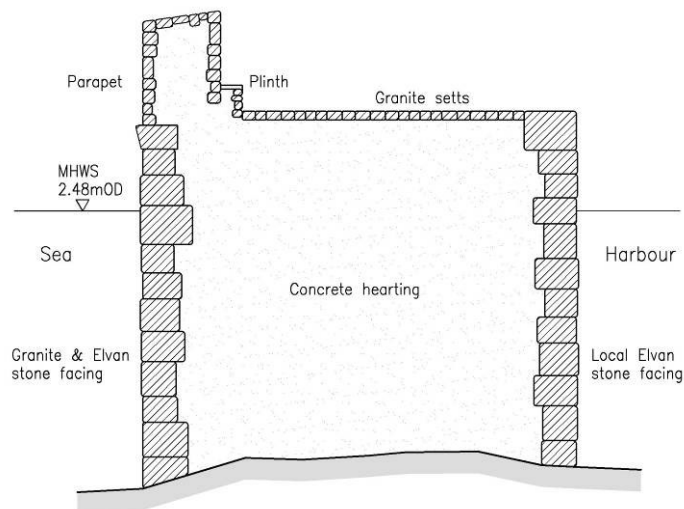
**Figure 2.7 Cross section of the Western Breakwater**

of the work is not as good as on the seaward side. The top of the Breakwater is paved with granite setts with a level surface suitable for vehicles. The end of the breakwater has had a considerable amount of remedial work carried out over the years, principally to maintain the existing construction, but also including the installation of vertical, inclined and horizontal steel ties. The construction is shown in Figure 2.7.

The Western Breakwater has a parapet which extends from the cliffs at the northern end to the lamp house and for approximately 2m beyond. The parapet has an average height of 2.1m and a width of 1.7m. The top of the wall slopes downwards towards the seaward side. The walls are constructed of dressed local stone brought to coursing with relatively wide joints. The core of the parapet is of concrete, placed in fairly small lifts (approximately 350mm). The parapet has a raised walkway alongside on the harbour side. A length of parapet was rebuilt in 1999 using a similar construction to the original, but incorporating steel dowels. At the time of the reconstruction the original concrete core was chemically tested and found to have degraded as a result of sulphate attack from the ingress of sea water.

All faces of the harbour structures were visually inspected, including the seaward side of the Western Breakwater by boat. Generally the walls were in good condition, but water was seen emanating from the Western Breakwater at the end and on the seaward side in a few locations and from the Northern Quay in the north west corner. This indicated holes or cracks in the facing with a void in the structure.

The surfaces of the Western Breakwater and Northern Quay were in reasonably good condition to line and level, but there is a need for some repointing (approximately 25%). The Southern Breakwater surface is not in such good condition, due to the original construction. The surface requires approximately 25% repointing, but the work involved is greater than with the setts. The slipway is in relatively good condition (stones are all in position) but approximately 40% requires some repointing.

Part of the wall above the steps to the Western Breakwater was slightly bulged. The parapet wall had some cracking on the seaward elevation.
