# 'Ruinous by Nature'

## THE ARCHAEOLOGY OF THE GROTTA AT CROOME LANDSCAPE PARK

### Summary

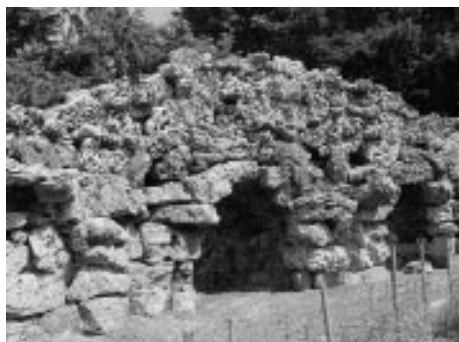
*The Grotto, Croome Landscape Park, following excavation, analysis and recording.*

In 1999 Project Archaeologist Rob Cleary, ably assisted by a strong team of volunteers, began investigations to the front of the Grotto. The entire area between the structure and the lake edge was excavated to reveal the line of the original footpath made up of rubble hardcore and ungraded river gravel, set in a deposit of reddish brown, silty clay. Within the larger of the two caves Rob found evidence to suggest that a stone seat was set at the back around a table. The floor of the cave was laid in regularly set cobbles to the rear, and more randomly set cobbles to the front, suggesting a period of disturbance and relaying. Certainly, it was clear that the cave had been disturbed by either robbers or souvenir hunters who had prised off almost all of the spars and fossils that had been inserted in the 1780s. A wrought iron gate had been set in place in the 1760s, but at some time in the late nineteenth century, this was replaced by an iron cage across the cave entrance, presumably as a deterrent to further vandalism. Nonetheless, the excavation revealed many fragments of spar crystals, predominately white calcite, purple amethyst, Blue John (feldspar), fossils, shell and coral, which were found surviving amongst the floor detritus.

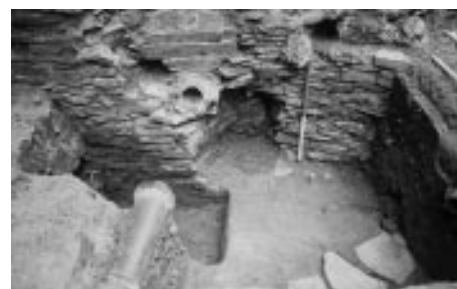
*Excavations of the water supply to the Grotto, Croome Park.*

How the water was supplied to the nymph statue and thus into the pond remained a mystery. Despite an initial investigation by Rob it was clear that further excavation was needed. In July 2001 Oxford Archaeology were contracted to tie up the work on the Grotto, as well as to undertake a series of other tasks throughout the park. Led by Project Officer Andrew Croft, the Oxford team undertook an excavation to the rear of the structure, revealing a limestone-covered land drain at a depth of 1.2m, presumably associated with the original draining of the marsh in the 1750s or with the preparations for

laying foundations for the Grotto. No evidence, however, could be found of the original arrangements for supplying water to the statue; it would appear that this was lost when the Grotto was last repaired in the 1970s, and only a modern ceramic pipe survives. The excavation did reveal the line of the culvert laid out by Snape in 1797 running into the lake just to the far western end of the Grotto. It was clear that the purpose of the culvert was not to supply water to the statue, rather to bolster a failing water supply to the lake. Documentary research suggests that the water was supplied from a reservoir in the neighbouring 'New Field', which itself was fed along a complex arrangement of culverts from springs to the north of the park, recently traced by consultant hydrologist, Nick Haycock.

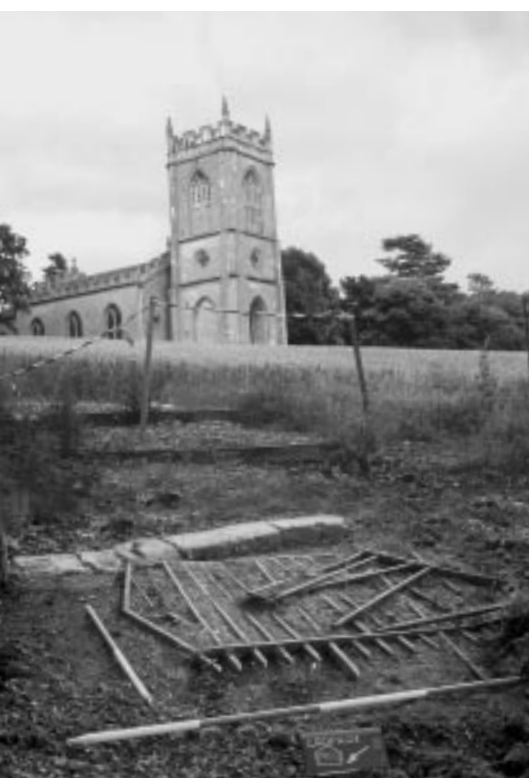
*Excavated gate on path leading to the church at Croome Park.*
