National Trust Arts, Buildings & Collections Bulletin

SPRING 2021

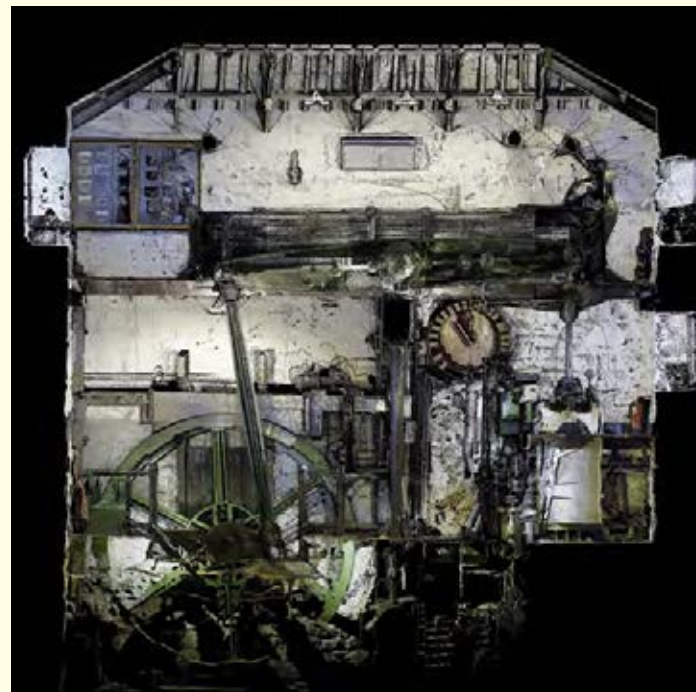
4. Cross-section through the Levant Engine House (NT) in Pendeen, Cornwall
Photo: National Trust Images/
Bill Stebbing

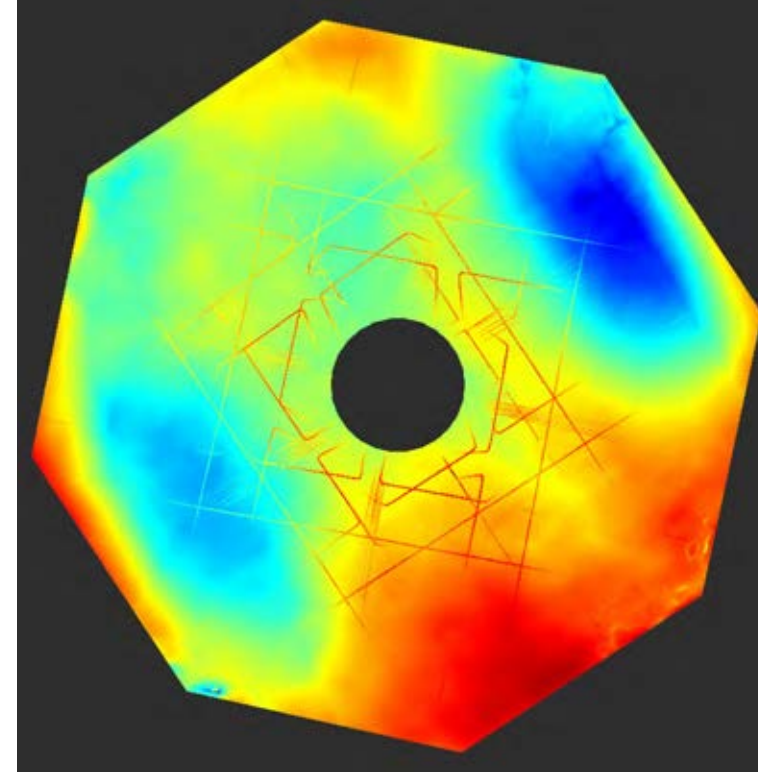
7. (above) Laser scan images of the Shell Gallery
Photo: National Trust Images/
Bill Stebbing

Multiple scans are needed to record the outside of a building in order for the lasers to reflect off every surface, with each scan taking 1.5–5 minutes, depending on the equipment used and the level of detail specified. This means that highly accurate surveys of buildings can be taken quickly both inside and out. Because a laser scan only records surfaces that are in its line

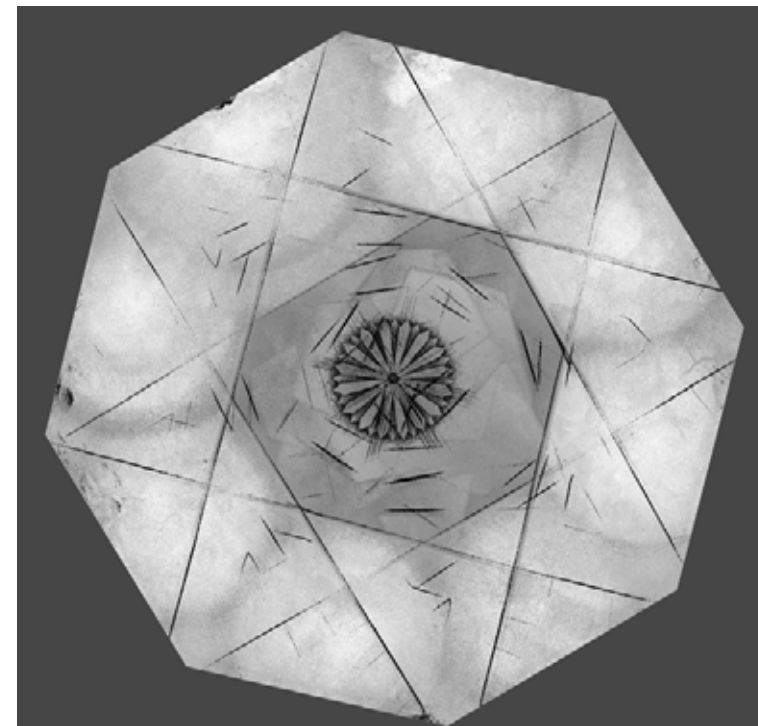
8a. and 8b. Two scans of the octagon ceiling reveal patterns largely invisible to the naked eye
Photo: National Trust Images/
Bill Stebbing

The laser scan of the ceiling showed that its surface varies in height by up to 25mm. It also identified odd striations, which form a distinct pattern. This was potentially evidence of a lost decorative scheme, tying in with earlier paint analysis that had suggested the possible presence of a stencilled scheme.

One scan appears to reveal a geometric pattern, while the second shows a central star extending across the ceiling. Both suggest that there are indeed missing elements of a wider coordinated scheme, intended to immerse the viewer. Although designed to be experienced from different vantage points, the primary view would have been directly upwards from the ground floor. From that perspective, the glittering decoration of the gallery perhaps served to represent a cluster of rock pools, glimpsed from the position of the seabed, while the ceiling provided a view of the night sky seen through the surface of the sea from below.

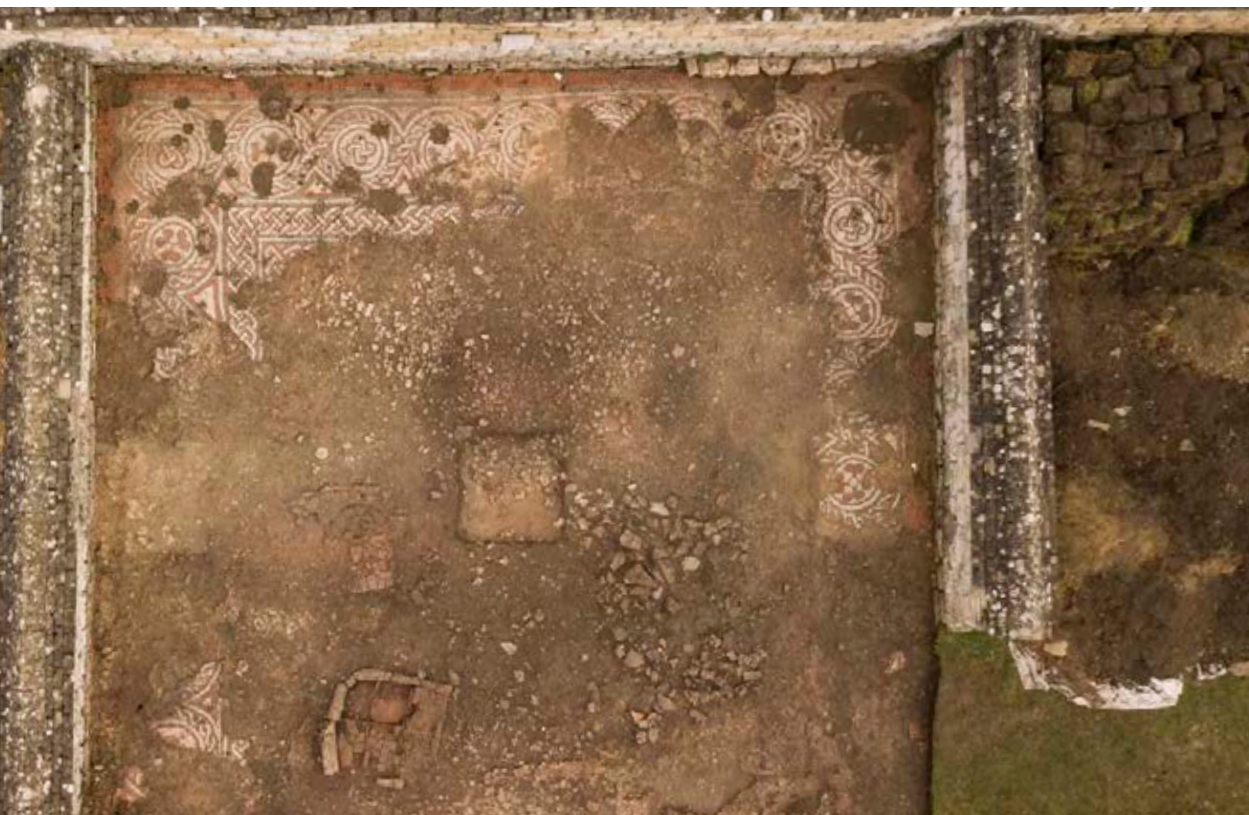
5. Room 27 trench in the south-east corner (looking south east) showing the dressed-block construction of the late 2nd-century south wall in contrast with the rubble footings of the east wall abutting it on the left. Note the valley slope of yellow Cotswold clay and brash bedrock levelled up with deposits of dark soil, which contained 2nd-century and earlier pottery
Photo: National Trust/Martin Papworth

Two trenches were dug in the north-east and south-east corners of Room 27, beside the wall dividing it from Room 28. Once the turf was cut and the topsoil cleaned down to the surviving Roman remains, it could be seen that the floor surface had almost been worn away apart from a thin strip surviving

against the north wall. Here, a remnant of a crushed brick and mortar *opus signinum* floor remained. This was supported on a hardcore of limestone gravel mixed with mortar. Once this was removed, the Cotswold limestone bedrock was seen, but it had been cut to create a foundation trench for the wall dividing rooms 27 and 28. The wall was built in the trench and then the gap between the wall and the trench edge was filled with a dark soil.

We were right about the south wall: our radiocarbon date of AD 75–219, at 95 per cent probability, was backed up by diagnostic pottery found in the soil that filled the foundation trench and in the layers it was cut through (for the 2nd–4th centuries, the broad date range of radiocarbon results makes pottery evidence more precise than radiocarbon dating). Despite this, we took the samples from the foundation trench fillings anyway and this decision was greatly rewarded. The result from the charcoal sample collected from the dividing wall foundation trench filling came back as AD 424–544 at 95 per cent probability.

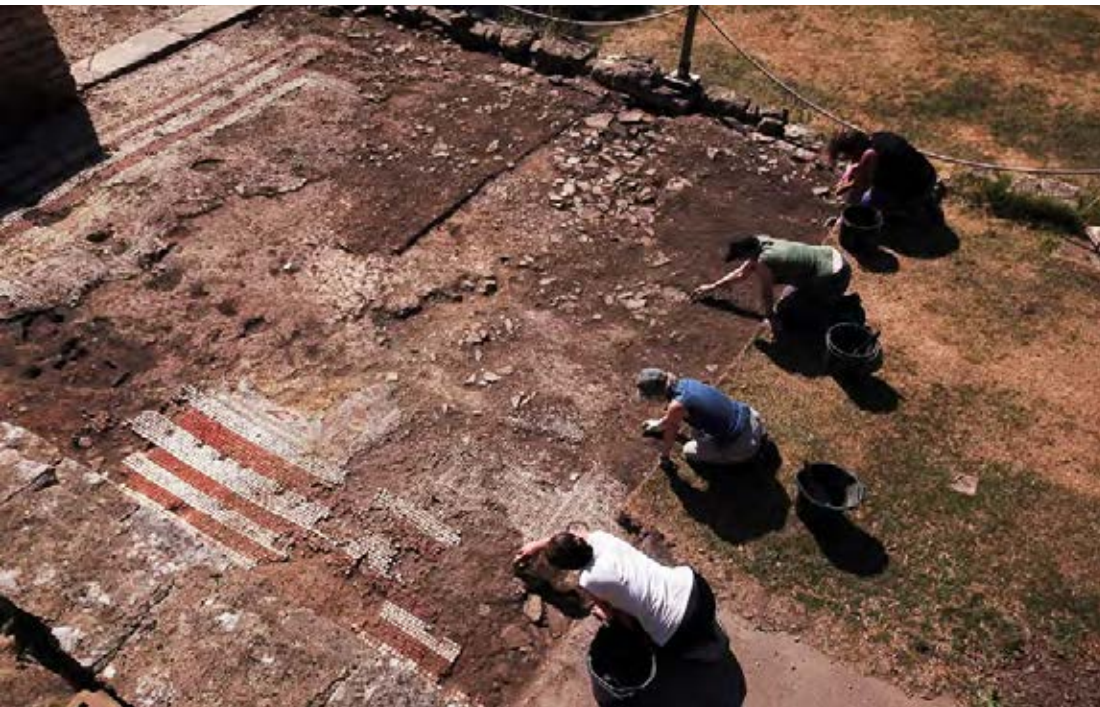
6. Drone photograph of the east end of the North Range Reception Hall 25b as it was being uncovered (looking south east): the original threshold stone for the doorway into the North Range Gallery can be seen at top left
Photo: National Trust/Mike Calnan

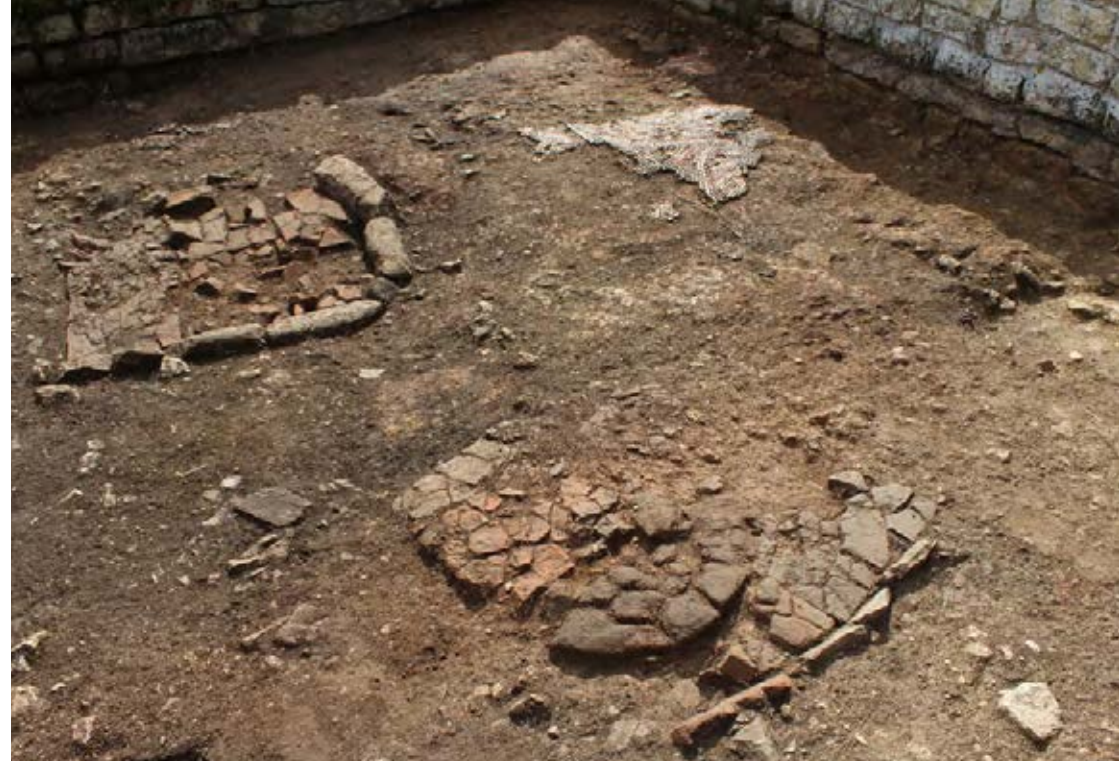
7. The two medieval hearths in Room 28 (looking south west): the hearth in the foreground is made of broken fragments of quern stones edged with tiles; the one in the upper left of the photograph is made from three reused Roman box-flue tiles, laid side by side and edged with limestone kerb stones
Photo: National Trust/Martin Papworth

The mosaic in Room 28 proved to be fragmentary, with only about 30 per cent surviving. The central design had been completely worn away and some later industrial function had caused burning in this area. Two hearths were found, one with reused quern fragments as a floor and the other with a limestone kerb surrounding three hypocaust box-flue tiles, laid side by side. Radiocarbon samples were taken from the burnt material within these tiles.

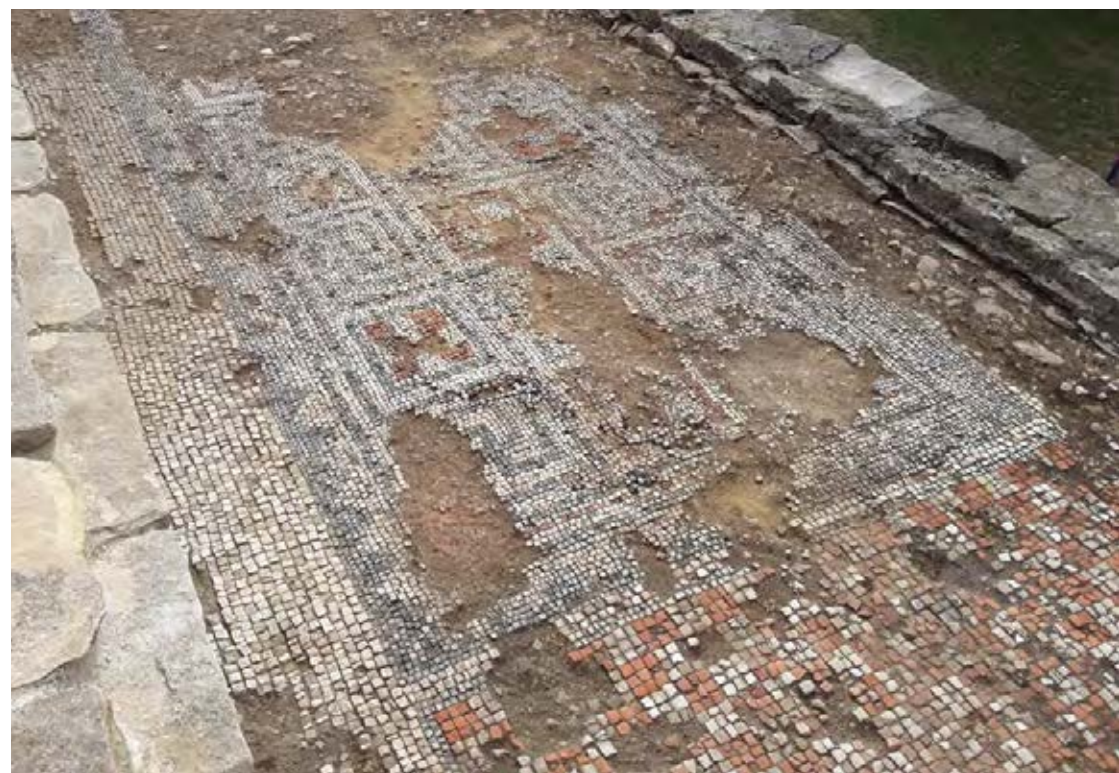
8. Room 33 in the North Range Gallery (looking east): the late-phase mosaic has a 'hop-scotch' arrangement with square motifs in pairs as positive and negative images of the same pattern followed by a single motif
Photo: National Trust/Martin Papworth

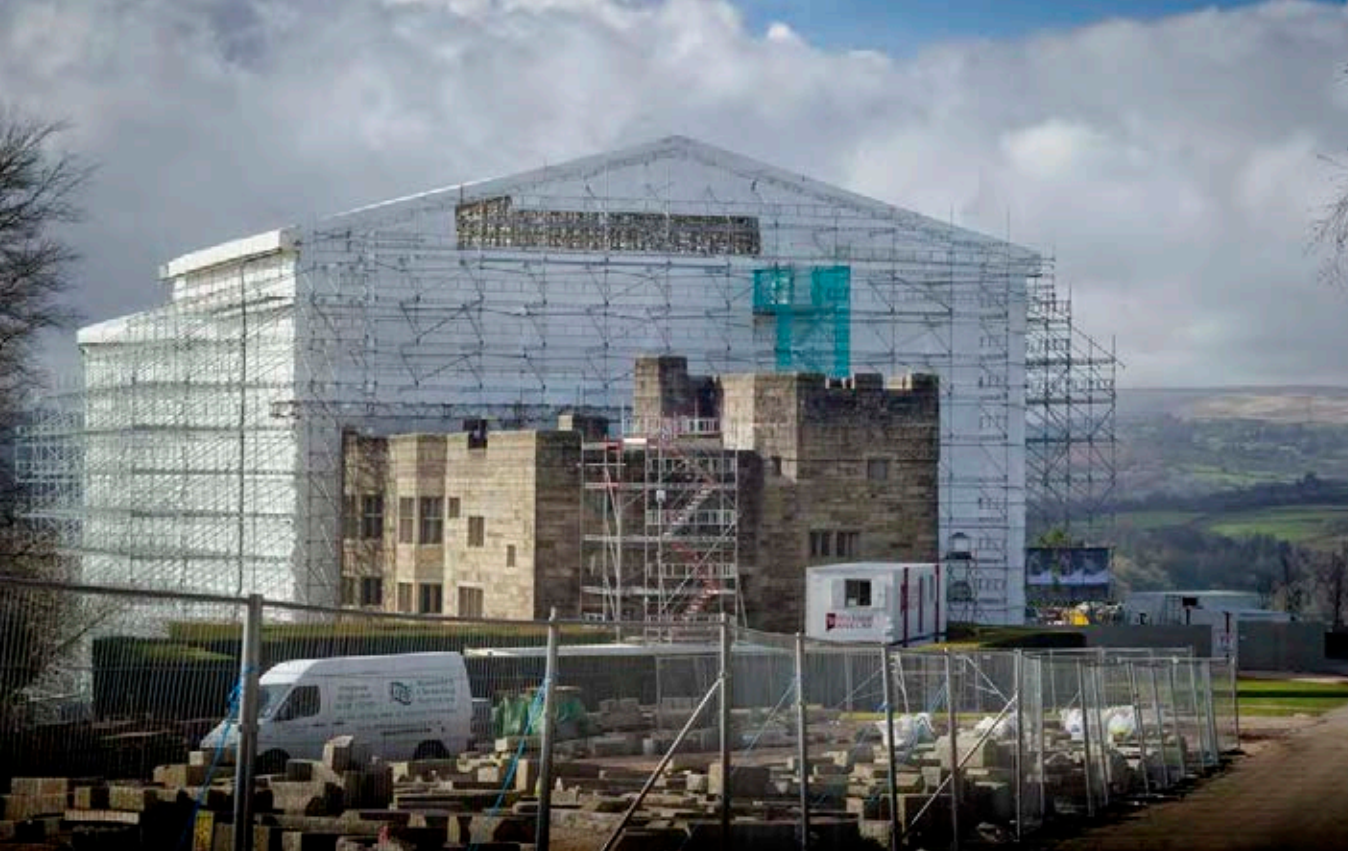
1. Castle Drogo under its vast scaffolding canopy
All photos: National Trust/Tim Cambourne

A new project started on site in 2013 with the aim of tackling the entire external envelope. It set out to replace the waterproofing across all the roofs with a modern membrane system; repoint all the walls with breathable hydraulic lime mortars; repair all external joinery; and remove, refurbish and reinstate all the windows.

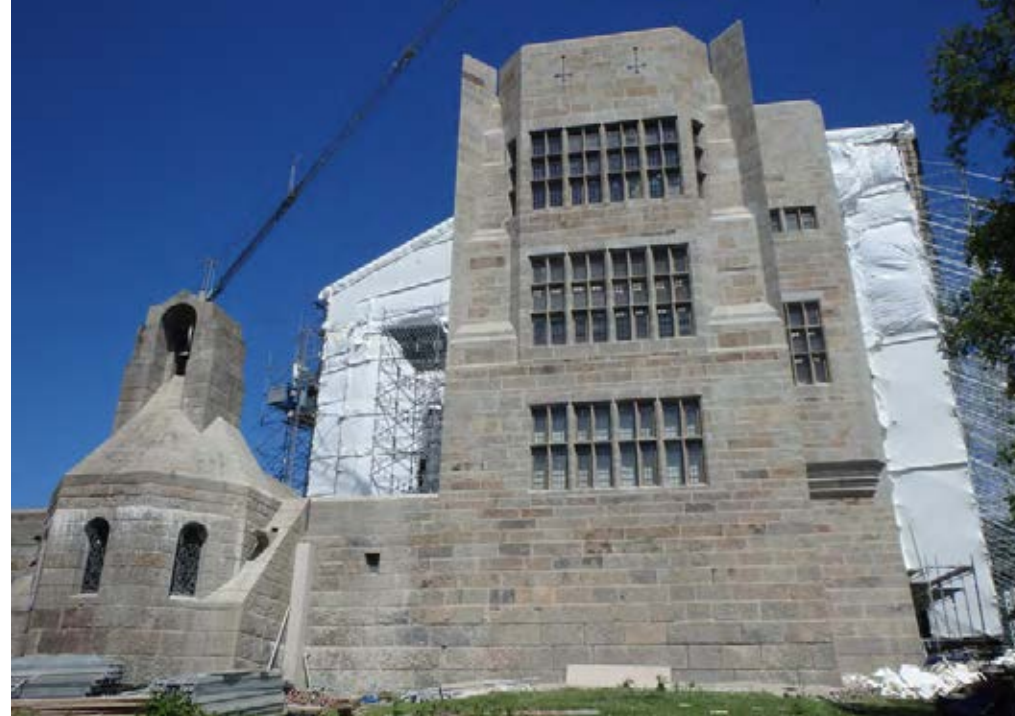
2. The south elevation and the Chapel, where the first phase of roof repairs was undertaken in 2006–7 as a full-scale trial of the materials and specification

Lutyens's design used in situ reinforced concrete slabs for the floors and roof. These were reinforced with steel filler joists at 400–450mm centres. Water ingress was increasingly putting the condition of the steelwork at risk, with serious rusting occurring in some areas.

The original asphalt covering was a very early use of the material and the detailing required wasn't well understood when it was laid. There were upstand kerbs formed against parapets and chimneys and tucked

into a mortar bed to continue through the wall as a damp-proof course. However, thermal movement in the material led to cracking of the asphalt at junctions and interfaces, leading to water ingress. Because the detailing hadn't taken into account the extent of thermal movement in the material, its failure was inevitable.

The repair approach used a membrane system designed for use in green-roof construction. This was used to replace all the asphalt coverings to flat areas and was also designed to create a continuous membrane across the whole roof. Where there were changes in level between roofs, it was therefore necessary to dismantle the granite outer skin of the wall, install the membrane and then rebuild the masonry: a huge undertaking and a major logistical challenge.

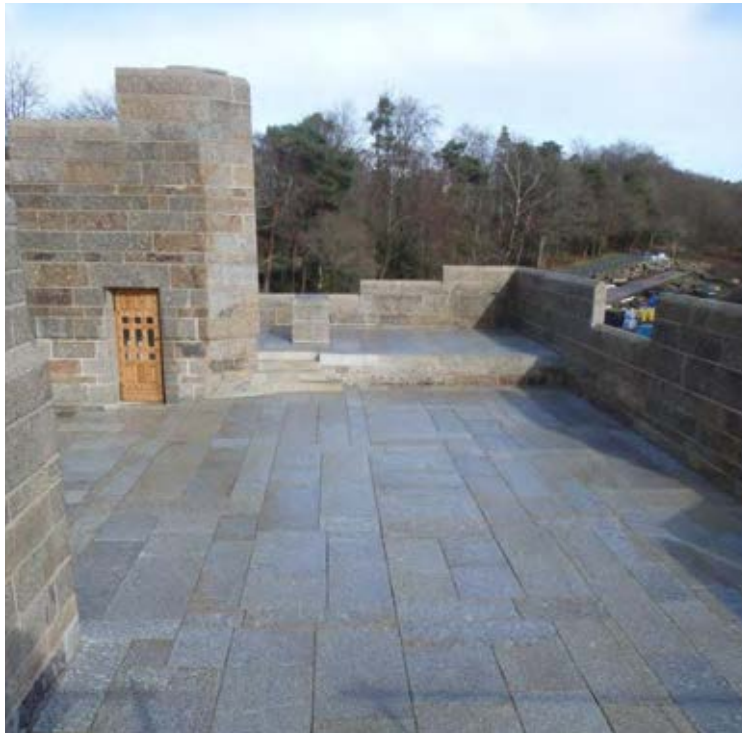
3. Paving on the north roof: the re-roofing project presented an opportunity to reinstate the original granite slab finish

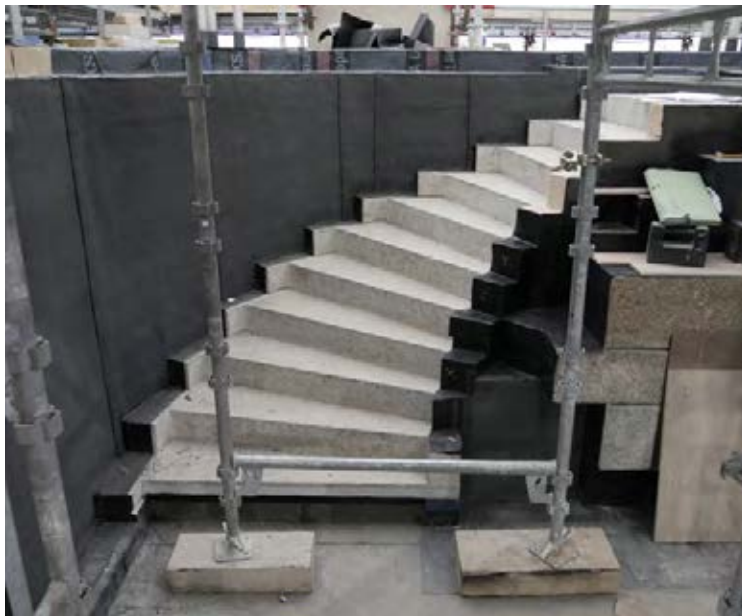
4. The North Tower stairs, showing the complex detailing of the membrane and damp-proof course

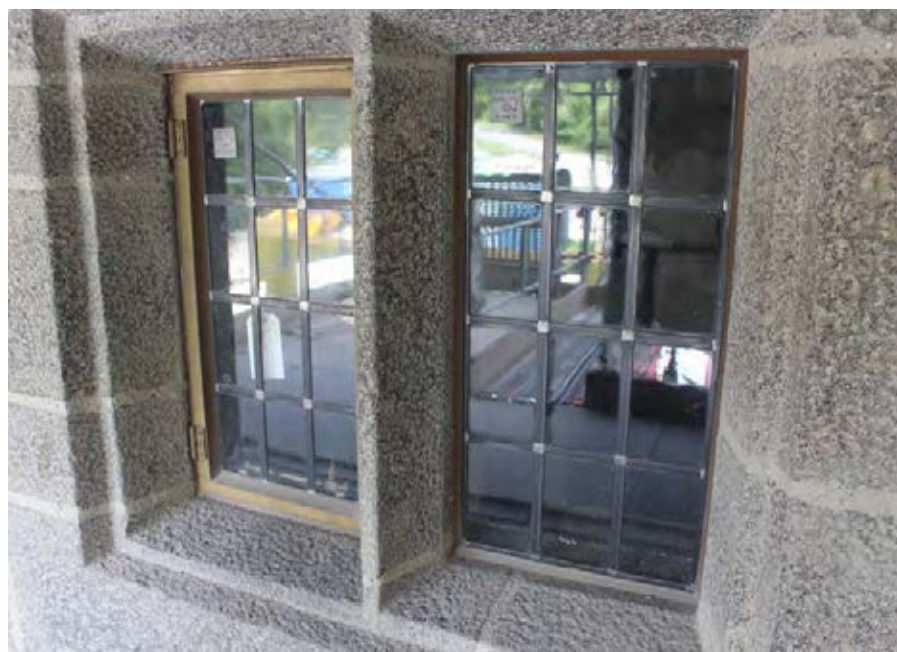
5. The castle’s 913 individual casements are difficult and expensive to access and maintain
